Air Conditioning System Performance of a City Hotel Appraised for Energy Use Efficiency

This paper presents results of a study on the performance of split air conditioning (AC) and overall energy consumption of a city hotel in Bali, Indonesia. The study applied a practical global approach to appraising energy performance of the AC system, overall electrical energy consumption of the hotel and frequent compressor damage as the impact of installation methods of the existing AC systems. The results obtained indicate that improper AC system installation method can reduce their energy performance which include COP (coefficient of performance), EER (energy efficiency ratio), and SEI (system efficiency index). The finding also shows improper installation method can cause enormous compressor damage. Within three years, as many as 54 compressors from 90 existing AC system in a particular building were damaged. Overall number of compressors that have been faulty in that period can reach 76 units accounted for about 23.1% of the total AC systems installed in the hotel. It is also found there is a reduction on AC system cooling capacity.

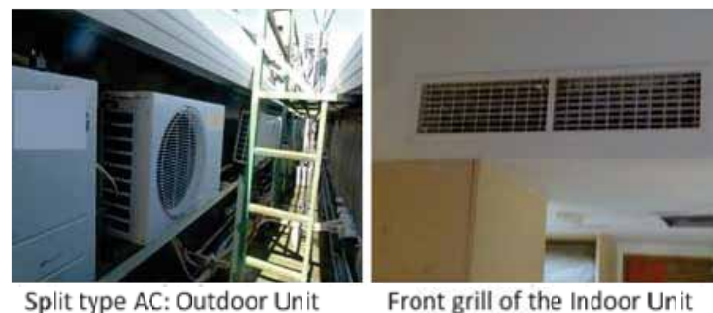
Fig. 2. Split AC system applied for Building-1

In the Building-1, the indoor unit used is a concealed type with forced flow. This indoor type chosen is quite uncommon. As a comparison, indoor of wall mounted type generally with induced flow. The concealed type with forced flow has a disadvantage of having air back pressure due to air burst into the evaporator coil. Back pressure causes the blower to require a higher static pressure head than induced flow. If the blower specifications used are the same as the induced flow, it may result in air flow shortage and it can be difficult to meet minimum flow requirements of the optimum cooling effect. It can get worse if the evaporator coil is dirty. Another drawback of a forced flow concealed type indoor construction which mounted above ceiling is that the difficulty of access to evaporator coil for regular cleaning. The evaporator is blocked by ducting from the indoor to the supply grill. Cleaning the evaporator coil is time consuming especially in preparing the access. For cleaning the evaporator only, the guestroom cannot be sold for about three days. This is one reason why cleaning the evaporator cannot be scheduled regularly by hotel management.

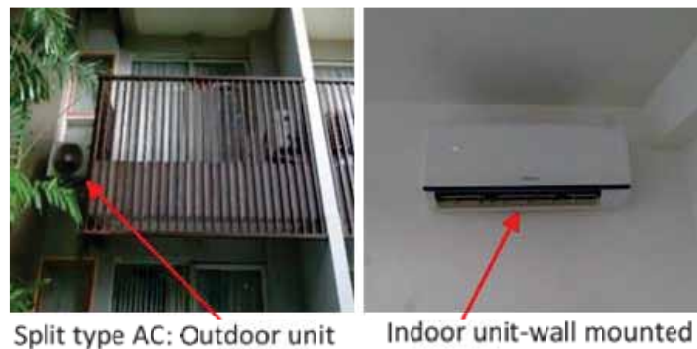
installed on the roof top with the outdoor position higher than the indoor unit. Typical installation of the AC systems can be seen in Figure 3.

Fig. 3. Split AC system installed in residence buildings

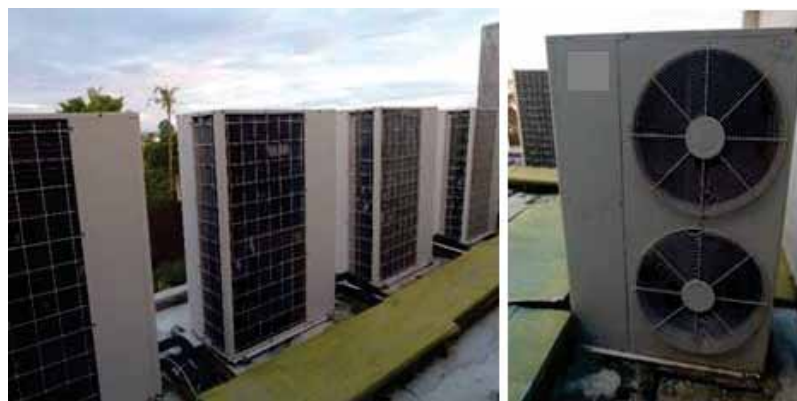
Fig. 4. The outdoor units of split AC systems for convention center

Installation of the AC system at the convention center seem to be considering access for maintenance and repair. Additionally, the installation has placed the outdoor unit elevation below the indoor unit. The outdoor unit installation of the AC systems is illustrated in Figure 4.

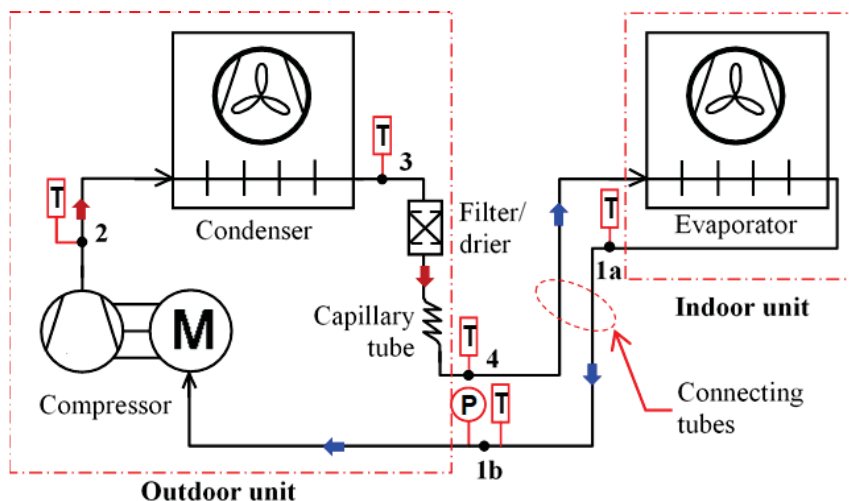
1a = evaporator outlet; 1b = compressor suction line; 2 = compressor discharge line; 3 = condenser outlet; evaporator inlet; T = temperature measurement; P = pressure measurement

Fig. 8. Schematic diagram of a split type AC system completed with site measurement points for energy performance investigation

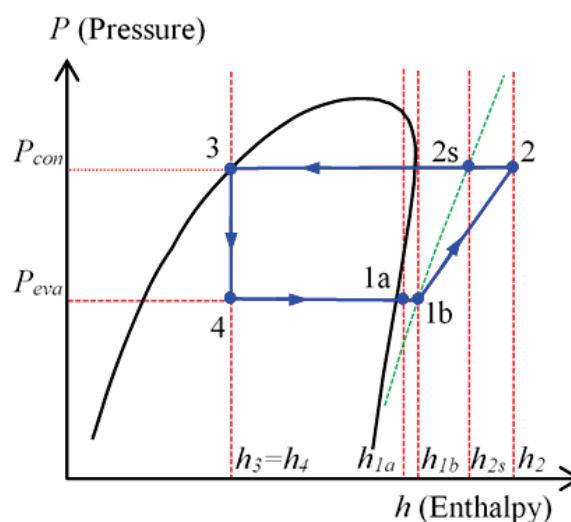
Assumptions were also taken to simplify the system evaluation which include: isenthalpic expansion in the capillary tube, insignificant pressure drops in the heat exchangers and connecting tubes, and 7% heat loss factor in the compressor. Refrigerant exiting the condenser is assumed to be saturated liquid due to difficulty to installed pressure measurement on the high pressure side of the existing system. There is no service valve at condenser side. To install a pressure measurement would require modification of the tubing system and make the AC system unable to operate for hotel services. This should be avoided in this appraisal. Based on these assumptions, refrigeration cycle of the AC system used for analysis is illustrated in a pressure-enthalpy diagram as can be seen Figure 9.

Fig. 9. Refrigeration cycle of the AC system in pressure-enthalpy diagram used for analyses
